DEVELOPMENT AND FABRICATION OF AN INSTRUMENT  
TO  
MEASURE INTEGRATED SKIN TEMPERATURE

CONTRACT NAS 9-4067

FINAL REPORT

AEROJET-GENERAL CORPORATION

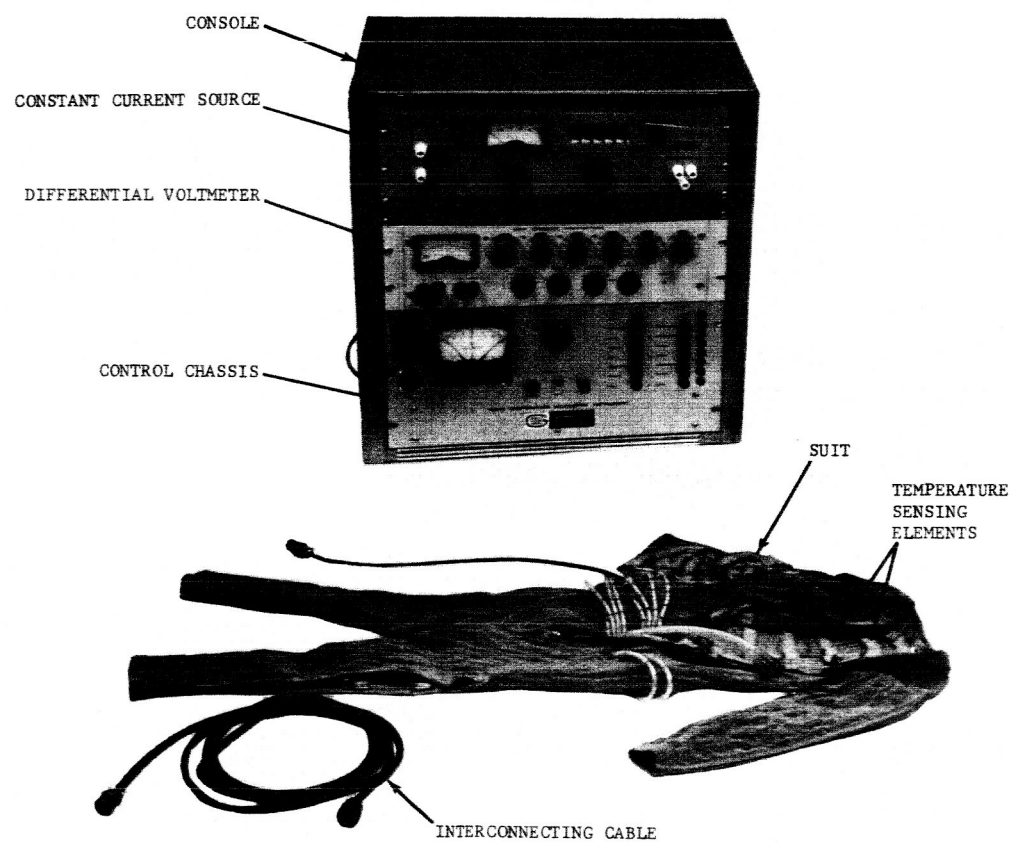
FIGURE 1 - SKIN TEMPERATURE MEASURING INSTRUMENT

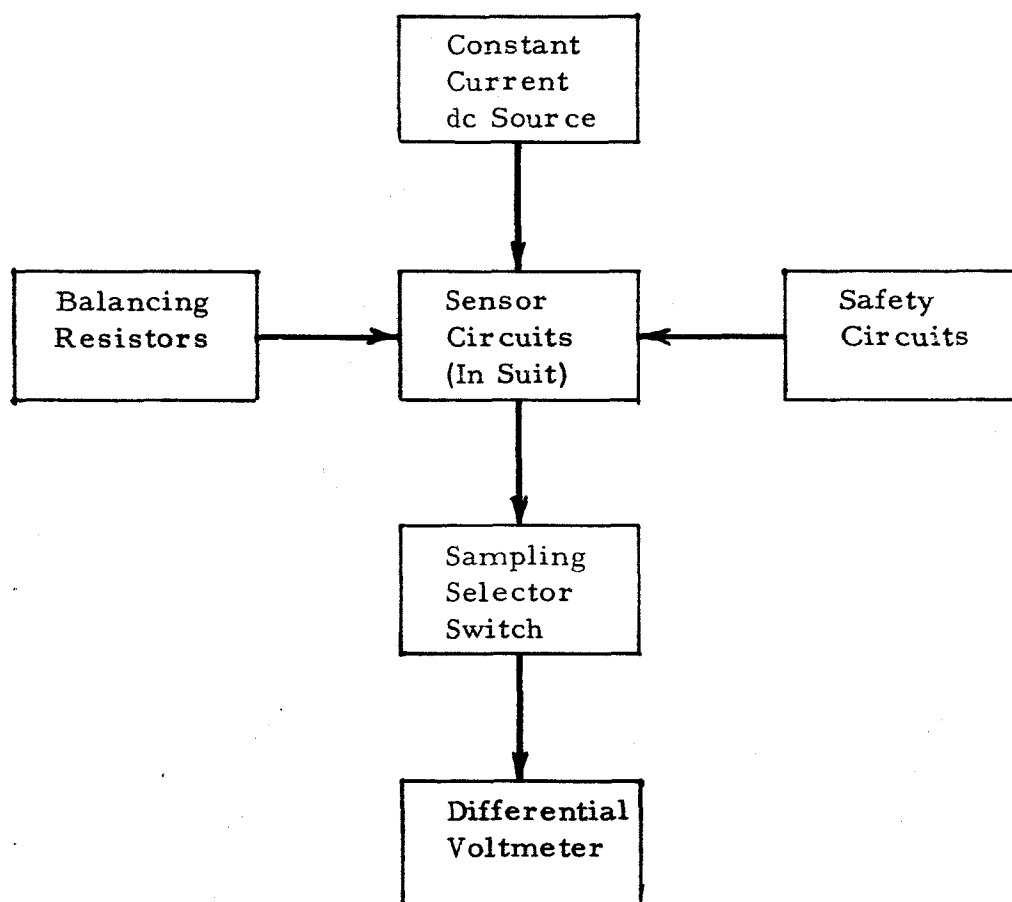
Figure 2 is a block diagram showing the interrelation between the various major components of the system. Figure 3 is a functional schematic diagram of these components which provides a basis for understanding the following discussions. A detailed schematic diagram of the system is provided in the operation and maintenance manual (Aerojet document No. IS-0953).

FIGURE 2 - BLOCK DIAGRAM, MAJOR COMPONENTS

The following discusses the various major components of the instrument as shown in block form in Figure 2 and in functional schematic form in Figure 3:

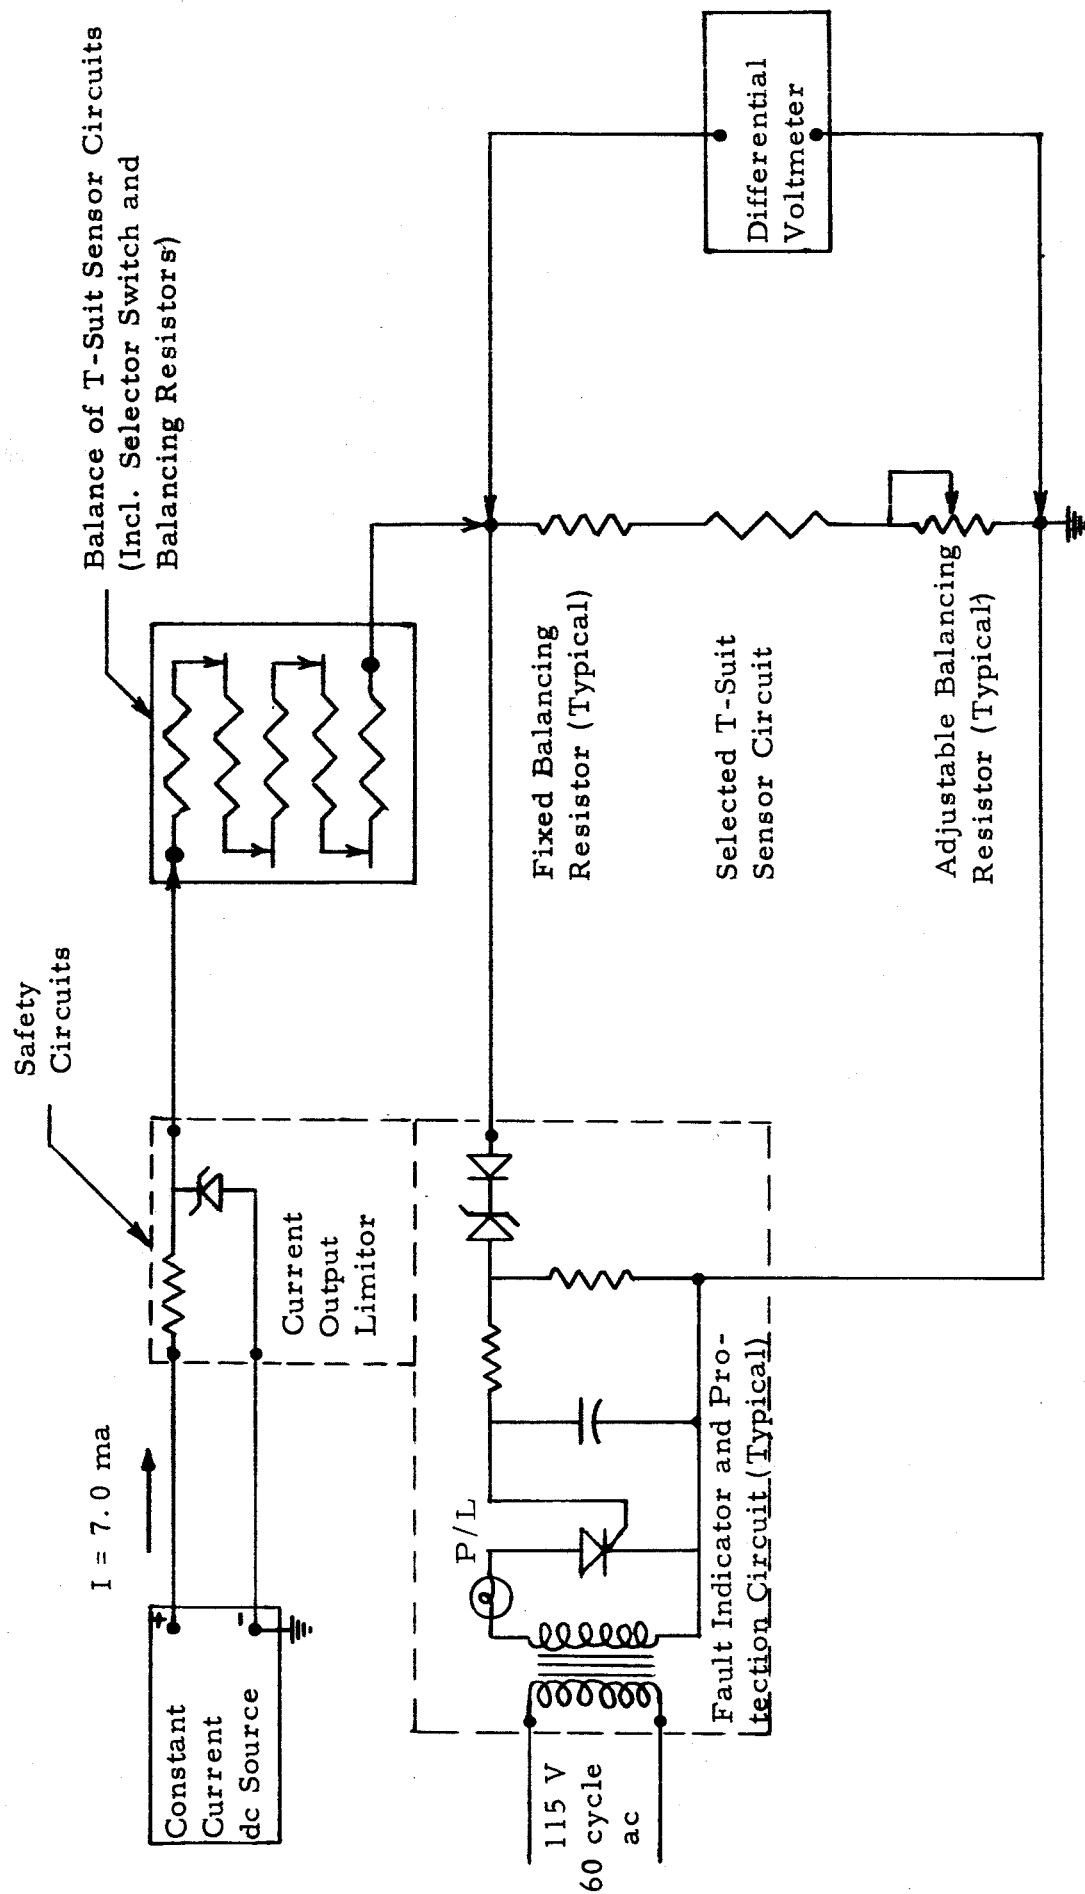
Referring to Figure 3, a constant current  $I = 7.0 \text{ ma}$  is generated by the constant current dc source. This current is passed through the series connected sensor circuits which are placed inside of the T-suit. The sensor circuits are made of insulated high purity nickel wire, and each separate circuit is of a different length (and thus resistance) as necessary to cover the area of the body over which it must sense integrated skin temperature. A sampling selector switch is used to select the desired sensor circuit across which the voltage drop is to be measured by a differential voltmeter. The selector switch is connected in such a manner that it grounds the node of the sensor circuit being measured, thereby providing a common reference point for all voltage measurements. Balancing resistors are connected in series with each sensor circuit such that the voltage drop across each selected sensor circuit can be adjusted to approximately the same voltage level for any selected calibration (body) temperature. A fault indicator and protection circuit is connected across each sensor circuit in such a manner as to limit the maximum voltage that can be developed across a break in any sensor wire

FIGURE 3 - SKIN TEMPERATURE MEASURING INSTRUMENT FUNCTIONAL SCHEMATIC DIAGRAM

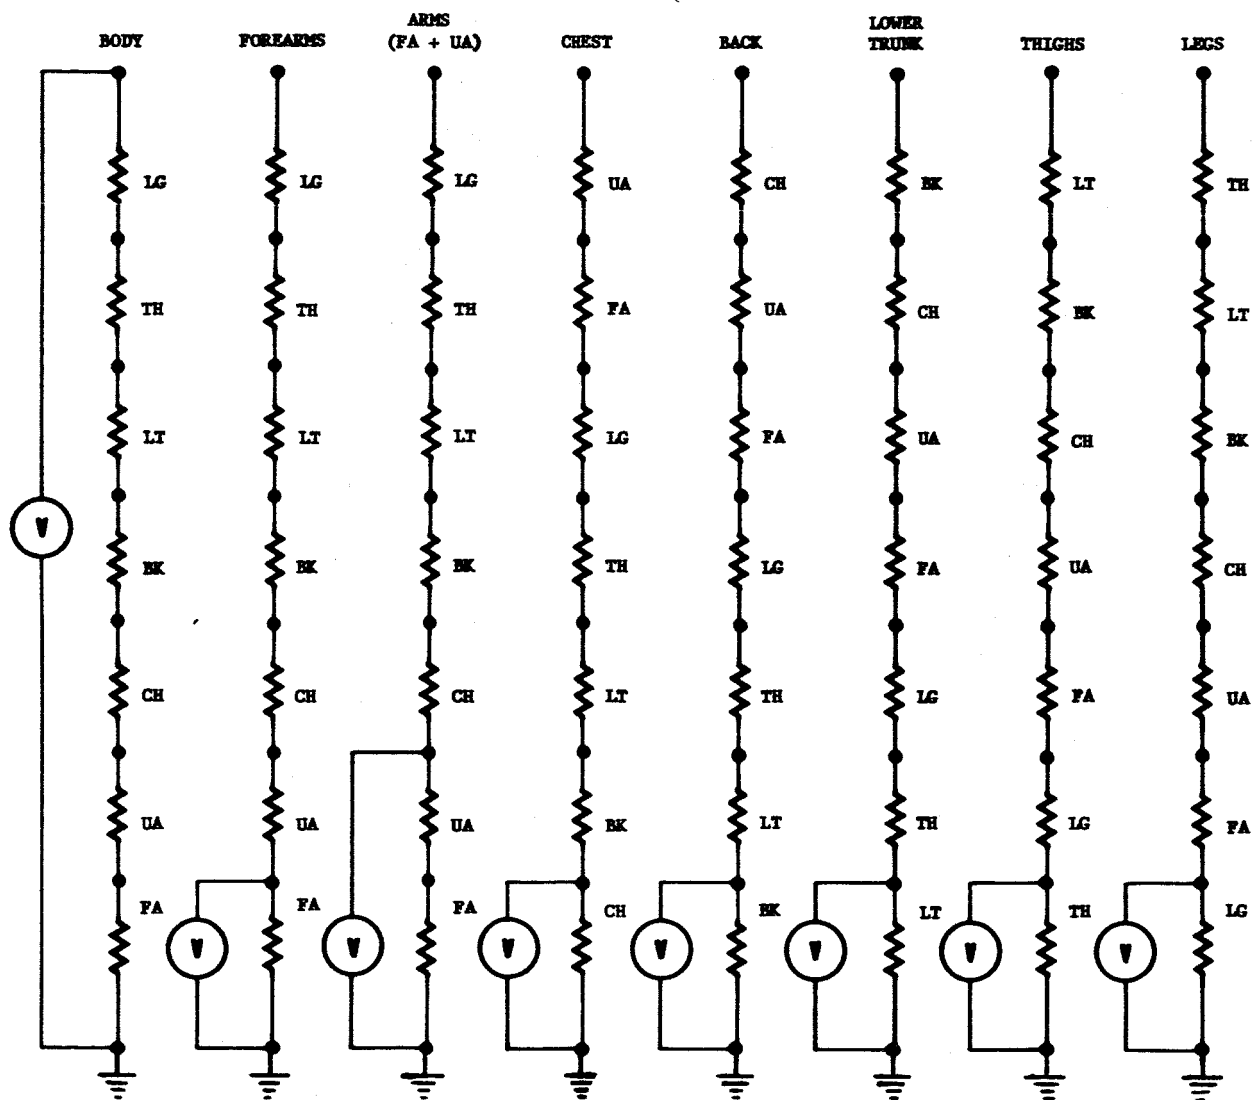
A selector switch is located in the console for the purpose of selecting the sensor circuit to be measured by the differential voltmeter. A second function of the switch is to ground the node of the circuit being measured, while simultaneously reconnecting the balance of the sensor circuits into a complete series connection, all in series with the constant current source. The switch was designed from a node and loop mathematical analysis which determined the minimum number of contact points and poles. The Centralab Company switch chosen for this application was selected primarily for its low contact resistance characteristics. Figure 4 illustrates the switching sequence provided by this switch.

FIGURE 4 - SWITCHING SEQUENCE

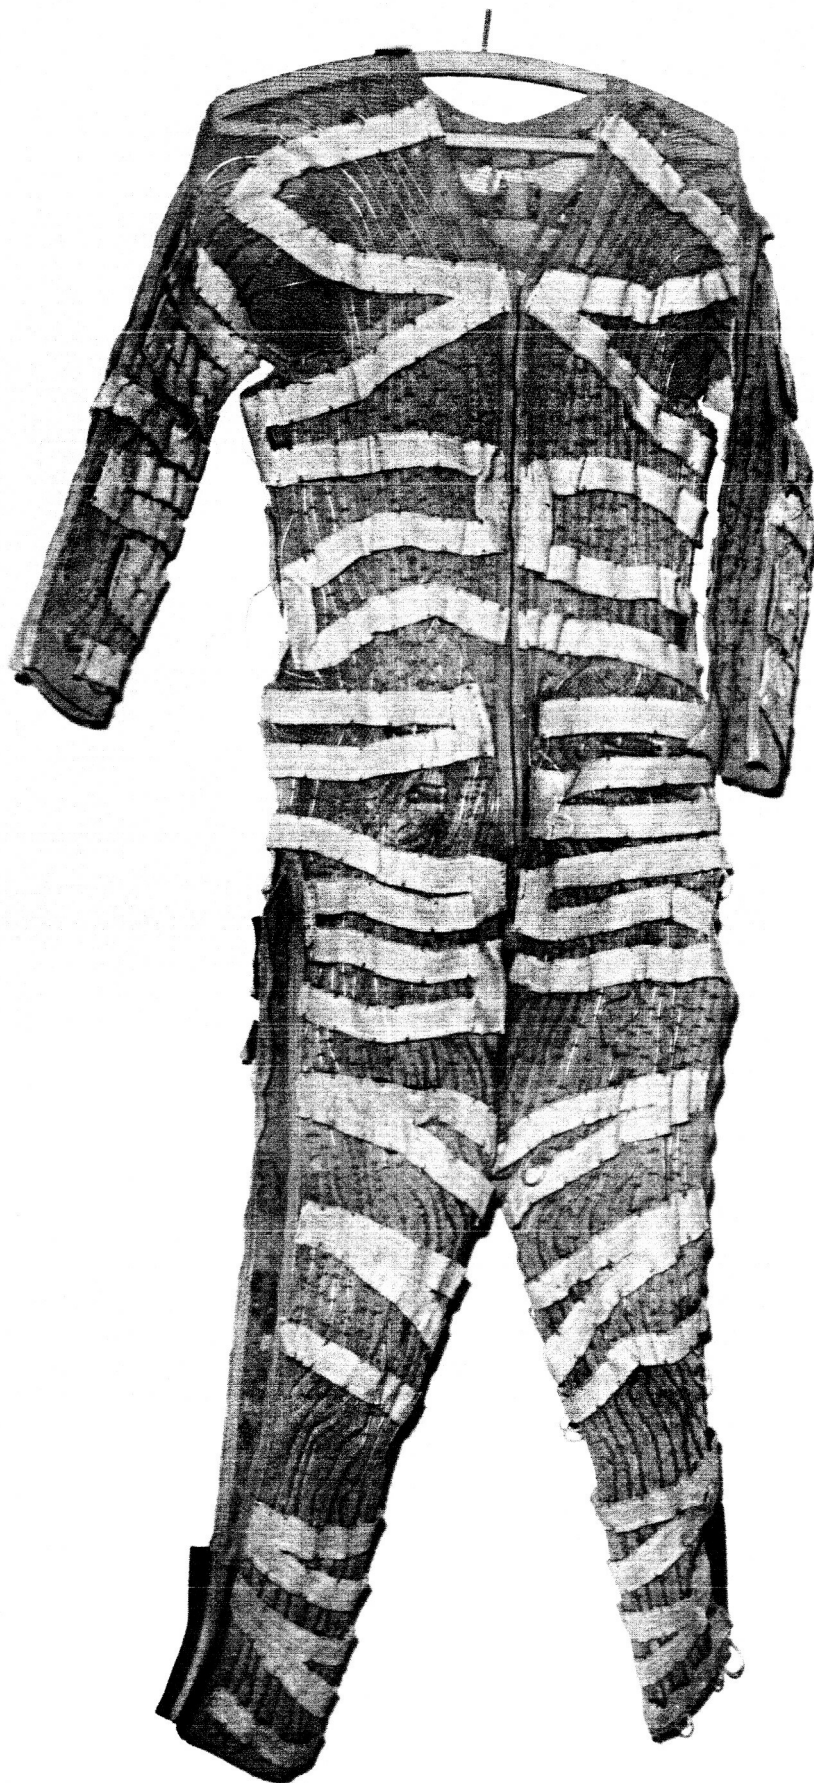
Figures 5 and 6 show the suit with the elements installed. The suit was turned inside-out for these photographs. The elements were fitted to the suit while it was being worn by a man who closely approximated the dimensions for a mean percentile man as defined in the U. S. Air Force "Handbook of Instructions for Aerospace Personnel Subsystems Design," AFSCM 80-3, 15 April 1965 revision.

FIGURE 5 - SUIT, FRONT INSIDE - TAPES INSTALLED

The sensor elements are composed of Formvar insulated 4 mil diameter high purity, fully annealed nickel wire sewn in a zig-zag pattern on the surface of 1.25" wide strips (or tapes) of flexible double knit cotton cloth. Fourteen separate sensor elements were fabricated, and appropriately interconnected to serve the seven individual sensor areas of the body. These were applied as follows:

The sensor elements were attached to the inside of the suit, over the surface of the cooling tubes, with the wire side of the tapes toward the body. They were attached with Velcro tape (patented nylon material that adheres to a mating material when physically pressed together) in such a manner as

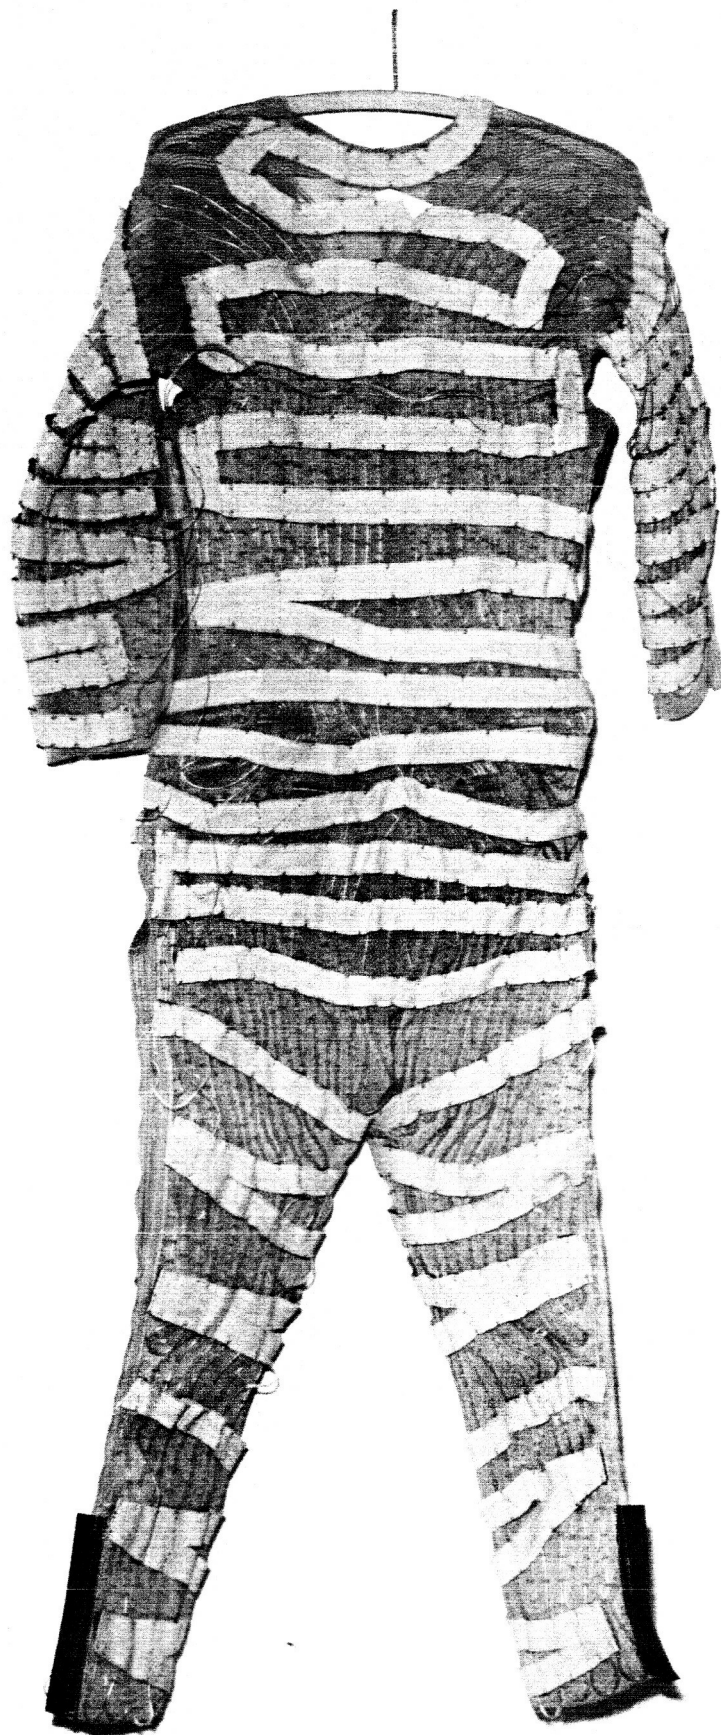
FIGURE 6 - SUIT, BACK INSIDE - TAPES INSTALLED
